Specific Target

Application: Houseboat/Marine Decks

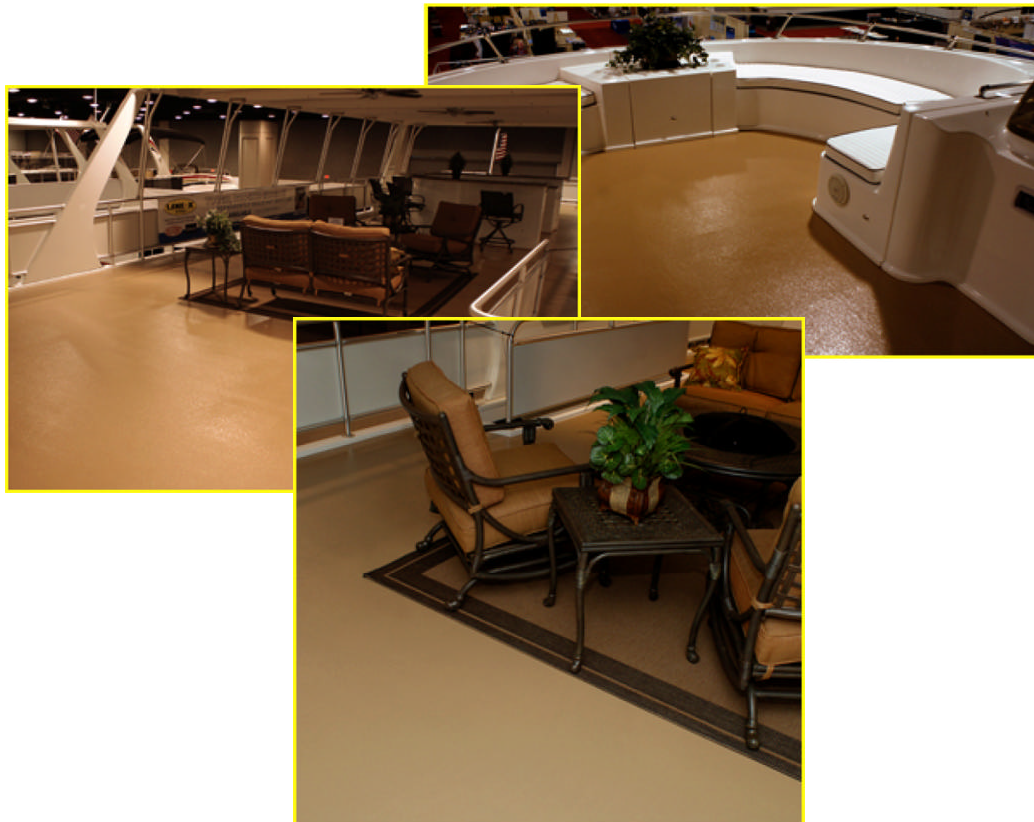
The Solution: The wooden deck below was first sanded, then coated with 125 mils (approximately 1/8th of an inch) of LINE-X XS-100. It was then coated with a proprietary topcoat, LINE-X XTRA, to give it a lasting glossy color coded finish. The total application time was approximately 1/4th that of the traditional gelcoat finish.

The Result: With superior tensile strength and abrasion resistance, the XS100 created a surface that was tough, functional, and aesthetically pleasing. In addition to providing superior protection, the LINE-X slip resistant coating helps prevent slip and fall injuries. Since LINE-X has zero VOC/CFC small repairs can be made waterborne decreasing maintenance cost.
